### The Long Road to BMD

A Multi-Year Study of Performance Tests

Compared to Field Data in CT

CONNECTICUT ADVANCED PAVEMENT LABORATORY

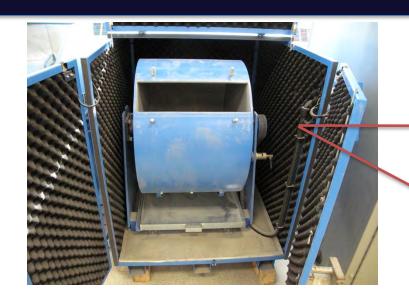
### Test Overview: Cantabro Test (Tex-245)

- Degradation Test Utilizing L.A. Abrasion Machine
- Ran on first 2 years of data
- Broke L.A. Machine Drum

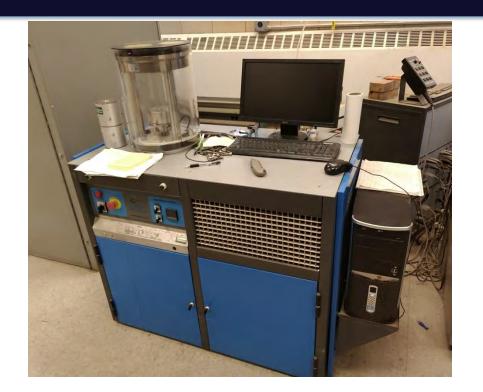
### **Test Overview: Flow Number Test (AASHTO TP79)**

- Initially identified as a rutting test [FHWA]
- Multiple years of testing CT Mixes suggested little to no correlation with other rutting data in our state [CAP Lab]

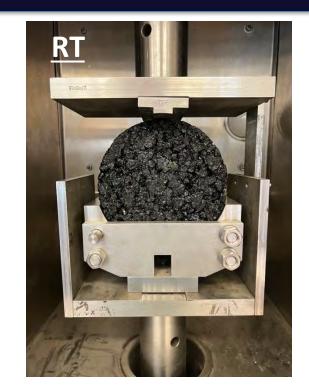
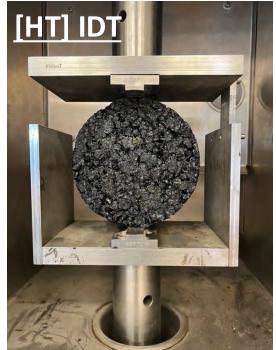
### **Test Overview: IDEAL RT / HT-IDT**

More recently developed rapid tests that are correlating well with longerduration wheel tracking tests.

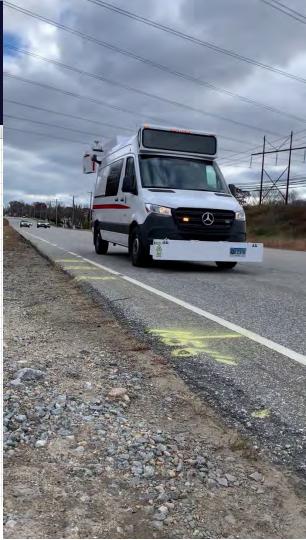
- Extract Condition data from CTDOT Automated Road Survey Vehicle
- Performance metrics for a given project length for a given surface age are averaged
- Identify trends between lab measurements and field observations

4	Α	В	С	D	E	F	G	н	1	J
1	Year	RoadName	From	То	Age	FunClass	MRI	WP	NWP	RUTmax
2	2017	001L	8.97	12.88	0	3	254.9	54.3	33.4	0.245
3	2017	001L	35.48	37.03	0	3	99.7	7.3	4.1	0.095
4	2019	005L	9.19	11.09	0	4	87.4	0.8	1.1	0.097
5	2018	005L	12.14	15.07	0	4	191.7	47.8	62	0.296
6	2016	008L	2.43	4.79	0	2	125	2	12	0.294
7	2018	008L	2.43	4.79	0	2	62.2	0.2	0.9	0.065
8	2017	008L	27.44	29.66	0	2	59.4	0.9	3.5	0.065
9	2017	008R	27.44	29.66	0	2	60	0.5	3	0.06
10	2019	008R	41.02	46.82	0	2	56.6	1.1	1.9	0.167
11	2017	016L	0	7.3	0	4	129.1	37.2	15.7	0.189
12	2017	030L	17.81	20.94	0	5	95.1	0.1	0.2	0.061
13	2018	031L	6.9	11.1	0	5	108.2	0.5	0.9	0.06
14	2016	032L	25.46	28.55	0	3	133.2	19.4	24.2	0.234
15	2017	032L	39.8	43.16	0	4	91.1	0.4	0.3	0.066
16	2017	037L	15.64	16.68	0	4	127.7	1.2	1.3	0.122
17	2016	044L	38.77	42.29	0	3	93	0.4	0.9	0.116
18	2016	084R	26.48	30.04	0	1	48.2	0	0	0.095
19	2017	091L	29.35	33.07	0	1	76.6	64.5	43.8	0.168
20	2016	095L	78.9	83.9	0	1	82.5	3.1	11.8	0.107

21	2017	095L	78.9	83.9	0	1	72.5	1.1	11.2	0.099
22	2016	095R	78.9	83.9	0	1	69.7	0.9	3.9	0.11
23	2017	095R	78.9	83.9	0	1	56.1	0.1	2.6	0.089
24	2017	095R	101.04	104.19	0	1	88	61.3	30.1	0.155
25	2016	097L	0	2.94	0	4	152.7	39.3	31.1	0.171
26	2017	136L	8.35	10.49	0	4	181.1	32.9	15	0.214
27	2019	140L	19.18	22.5	0	5	141.7	0.5	0.6	0.124
28	2019	142L	1.14	1.76	0	4	113.2	0.2	1	0.065
29	2017	148L	6.88	10.27	0	5	73.1	0.3	0.3	0.077
30	2018	167L	4.96	10.41	0	4	93.5	0	0	
31	2017	179L	8.77	12.06	0	5	90.6	0.4	0.5	0.102
32	2017	272L	6.02	10	0	5	271	51.5	20.5	0.392
33	2017	3131	0.57	3 42	0	4	91.6	2	12	0.08
